State of Illinois
ENVIRONMENTAL PROTECTION AGENCY
MEMORANDUM

DATE: November 8, 2010
TO: Division Files - Bureau of Land
FROM: Chris Cahnovsky – Collinsville Region
SUBJECT: 1198010003 – Madison County
Estate of Chemetco
FOS File

On November 3, 2010, Michelle Cozadd and I conducted an inspection at Chemetco, Inc. Present during this inspection were Jorge Garcia, ES&H Manager for the Estate of Chemetco, Duane McVey from the Estate and Mike Murray of AIS.

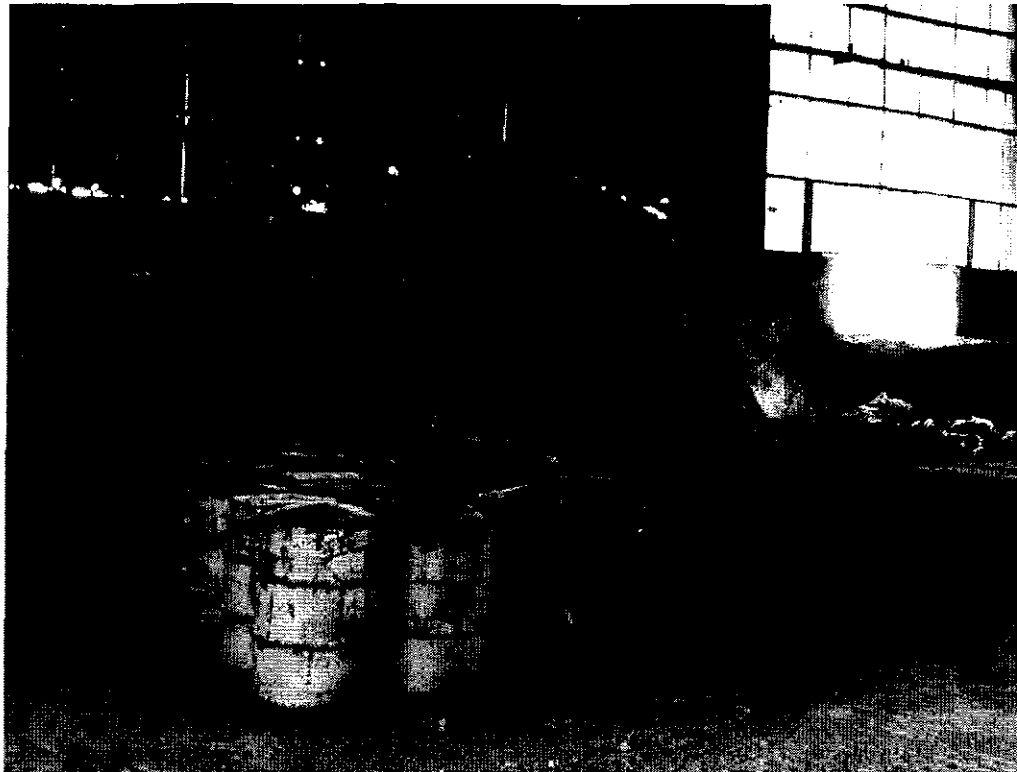
Date: 11/03/2010
Time: 12:50 – 2:30
Direction: West
Photo by: Chris
Cahnovsky
Exposure #: 005
Comments: Empty
drums that once
contained material
mixed with pot slag.
Also are on foundry
floor where drums
were dumped and
mixed with pot slag

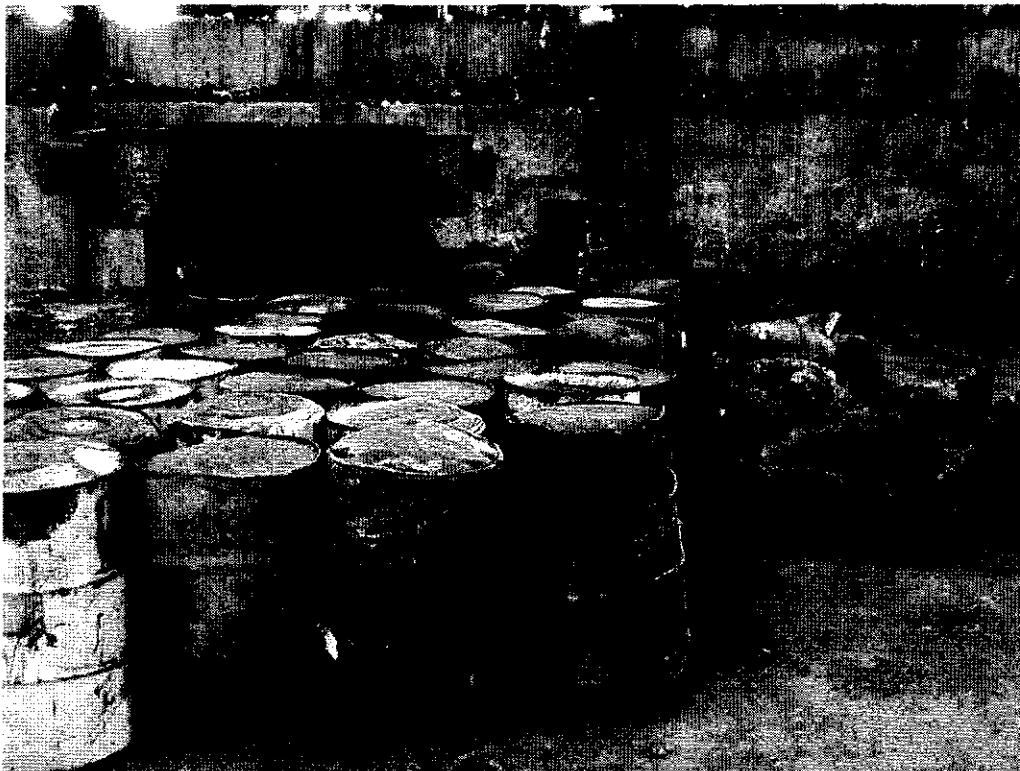
Date: 11/03/2010
Time: 12:50 – 2:30
Direction: West
Photo by: Chris
Cahnovsky
Exposure #: 006
Comments: Empty
drums that once
contained material
mixed with pot slag.

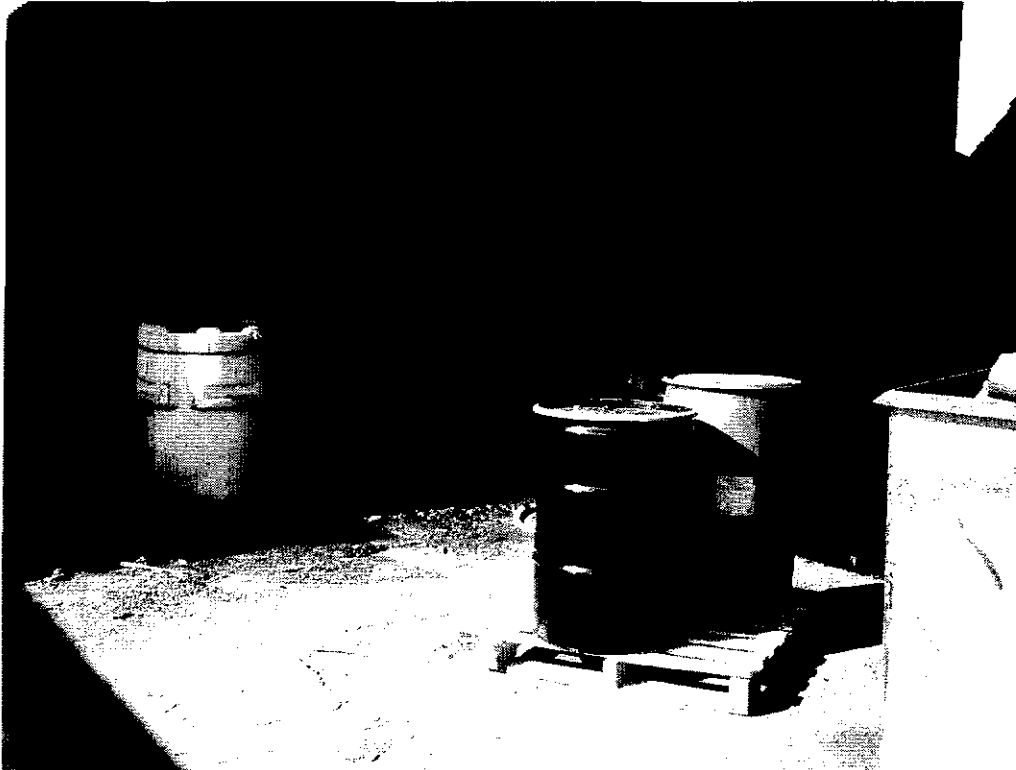
Date: 11/03/2010
Time: 12:50 – 2:30
Direction: Northwest
Photo by: Chris
Cahnovsky
Exposure #: 007
Comments: Decon
water and PPE
generated from pot
slag removal.

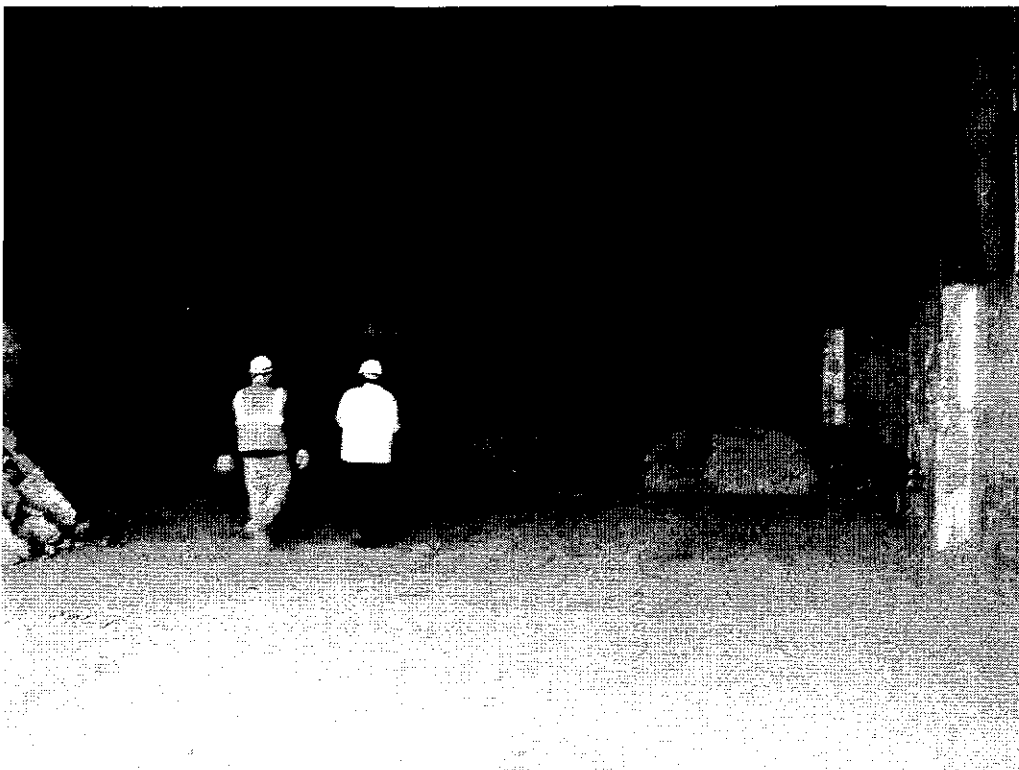
Date: 11/03/2010
Time: 12:50 – 2:30
Direction: Northwest
Photo by: Chris
Cahnovsky
Exposure #: 008
Comments: Fines
Building

The tarp on the Fines Building was closed. The pile of concrete and debris is still in the Fines Building. AIS has sampled the debris. I was told that David Herrera had the results.

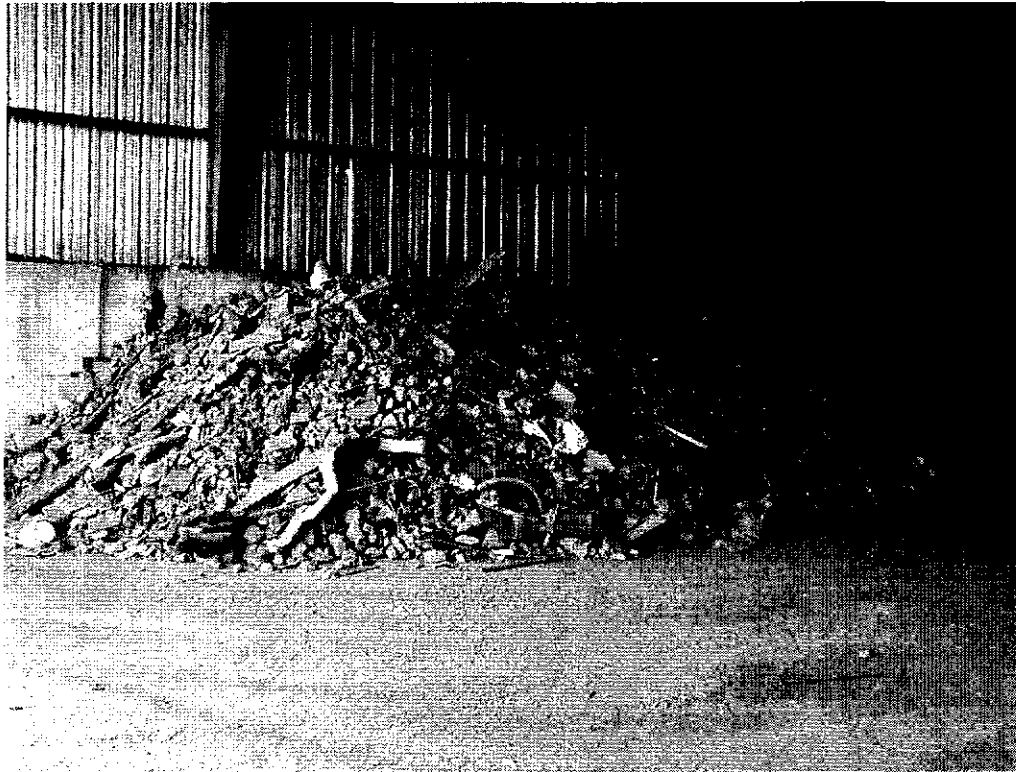
Date: 11/03/2010
Time: 12:50 – 2:30
Direction: Southwest
Photo by: Chris
Cahnovsky
Exposure #: 009
Comments: Concrete in
Fines Building

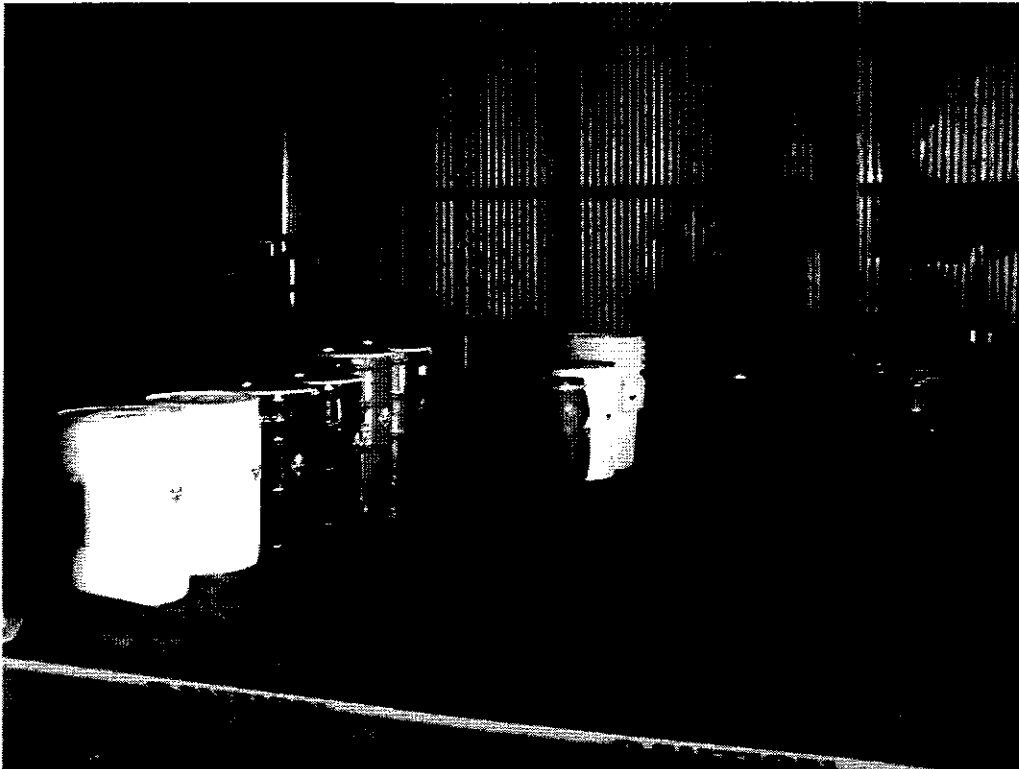
Date: 11/03/2010
Time: 12:50 – 2:30
Direction: East
Photo by: Chris
Cahnovsky
Exposure #: 010
Comments: Lab packed
waste

In the Tank House I observed that the miscellaneous chemical containers collected from the Tank House have been combined into lab packs. I observed about 28 containers of waste. AIS is currently in the process of profiling the waste with Heritage Environmental. Next to the lab packed drums I observed three rows of 55-gallon drums. Each row contained about eleven drums. The first two rows contained grease and the third row contained oils. Per Mr. Garcia, the Estate is looking for a company to recycle or dispose of the oil and grease.

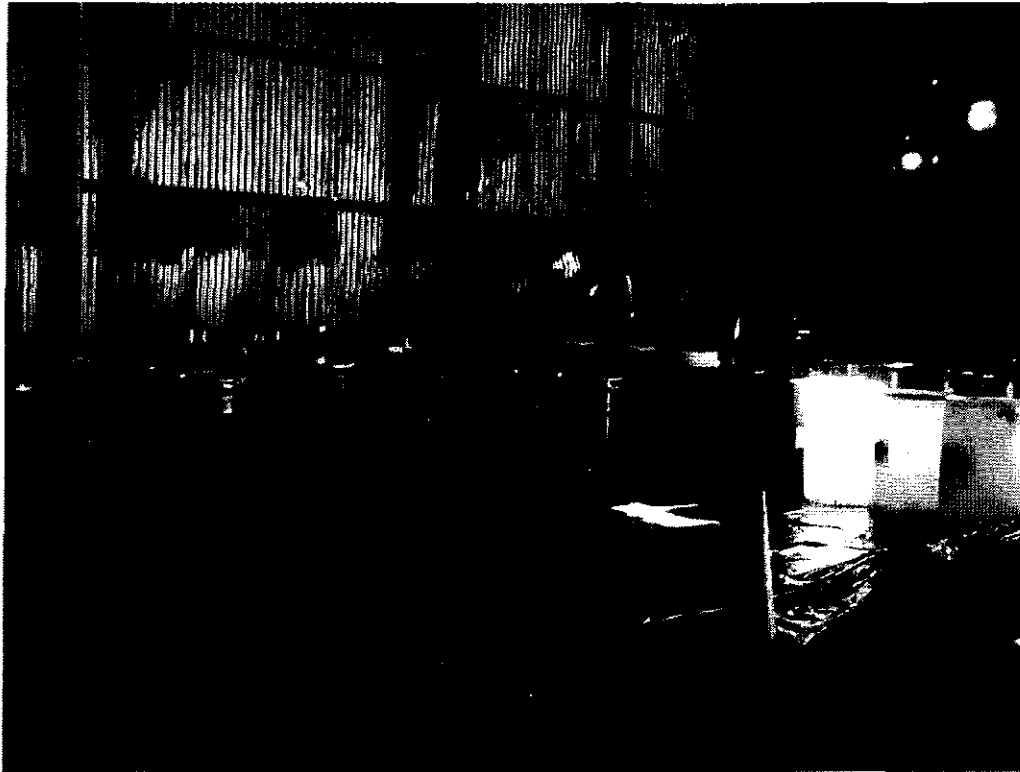
Date: 11/03/2010
Time: 12:50 – 2:30
Direction: Southeast
Photo by: Chris
Cahnovsky
Exposure #: 011
Comments: Lab packed
waste

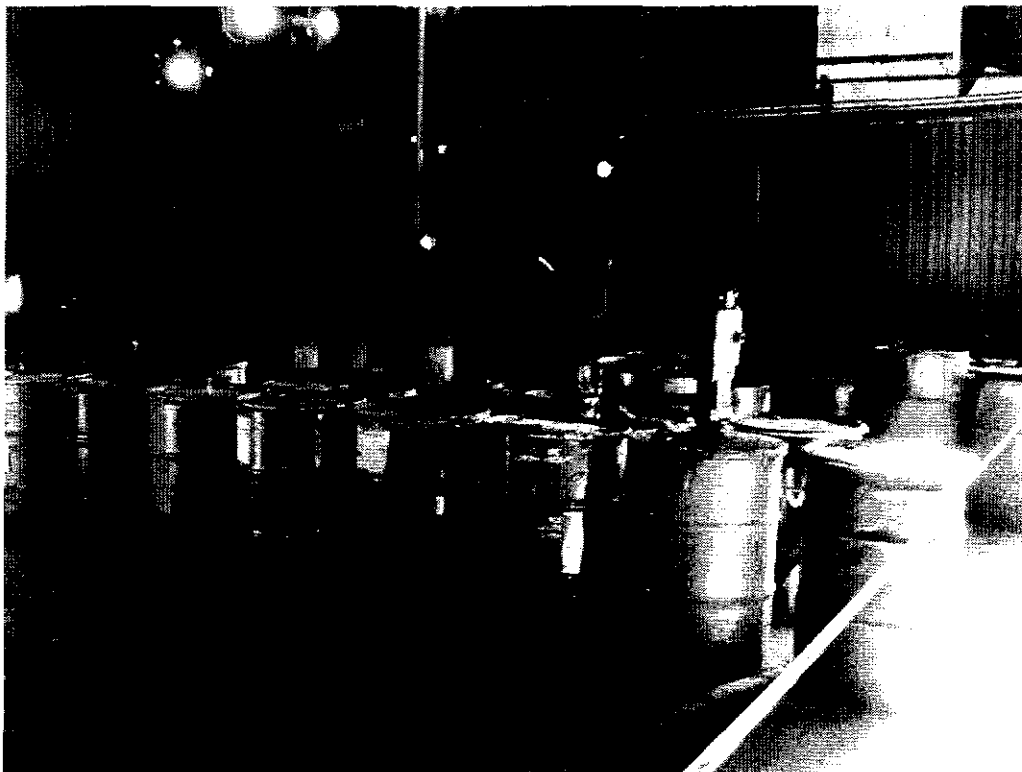
Date: 11/03/2010
Time: 12:50 – 2:30
Direction: Southeast
Photo by: Chris
Cahnovsky
Exposure #: 012
Comments: Roll of
grease drum
collected around
facility

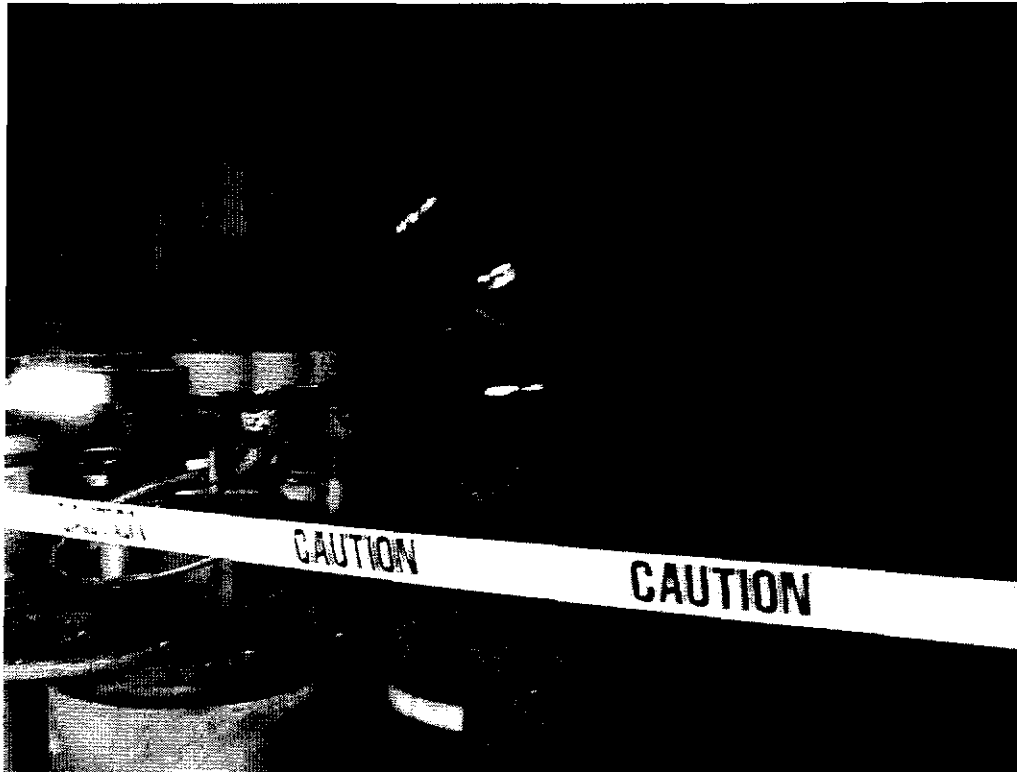
Date: 11/03/2010
Time: 12:50 – 2:30
Direction: Northwest
Photo by: Chris
Cahnovsky
Exposure #: 013
Comments: Drums of
oil collected around
facility
